The Rüdlingen Monitoring and Landslide Experiment

A large scale field experiment was conducted on a steep forested slope in north Switzerland to trigger a landslide by means of artificial rainfall. The experiment was successful and has delivered valuable knowledge about the behaviour of landslides.

by Sarah Springman, Amin Askarinejad, Peter Kienzler, Francesca Casini, Marco Sperl, Ernst Bleiker / IGT; Devrim Akca, Armin Grün, Professur für Photogrammetrie / IGP

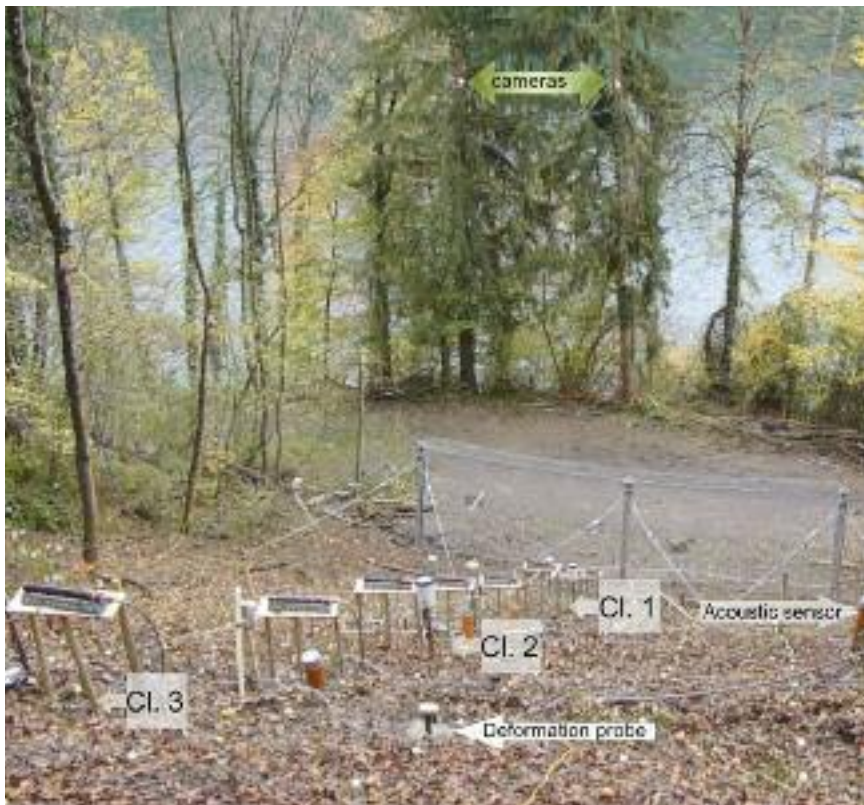
Fig. 4: Location of the instrumentation clusters (Cl. 1 – 3), the sprinklers and the photogrammetry cameras.

A 4-camera arrangement was adopted for the image acquisition. IDS cameras were placed in housing shields to protect them against environmental effects and two each were equipped with 8.0 mm and 12.0 mm C-mount lenses. They were fixed on two tall trees at the foot of the slope (Fig. 4) at approximately 25 metres height by a professional climber. Approximately 250 white ping-pong balls (with diameter 40 mm) were glued onto wooden pegs and embedded in the ground in a 1 m by 1 m grid (Fig. 4). 21 well distributed ground control points were established on the surrounding stable trees. The a priori point positioning accuracy of the ping-pong balls, using an in-house developed network simulation tool, was estimated as ± 10.3 mm along the horizontal direction and ± 3.5 mm along the vertical direction. In the second sprinkling experiment, the area of interest was moved ca. 5 metres up the slope. In order to make the targets more discernable on the image space, the ping-pong balls were replaced with approximately 80 white tennis balls. A posteriori point positioning accuracy

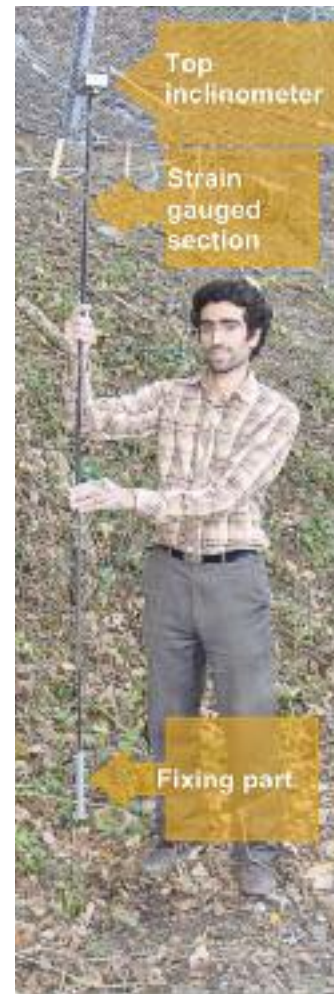
Fig. 5: Deformation probe.

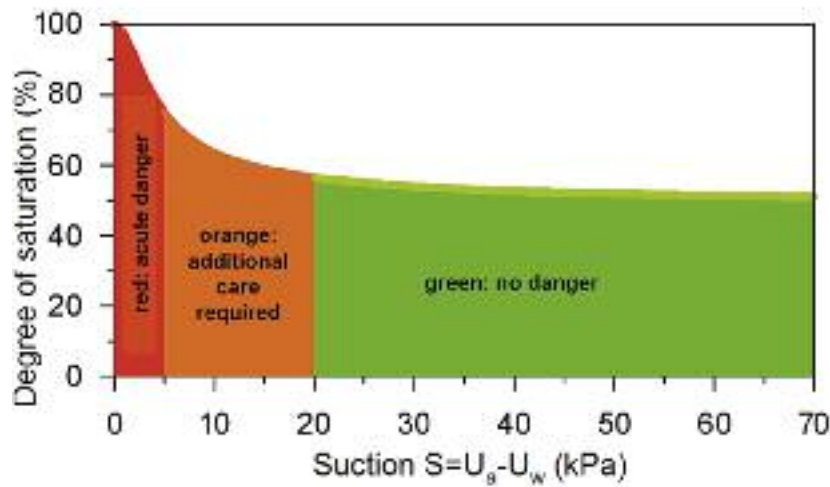
Fig. 6: Decision – making graph for the observational method.

The reasons why a slope fails suddenly due to rainfall can be compared to the collapse of a sandcastle due rainfall or flooding. The capillary action of at the water-air-soil particle interface in partially saturated ground adds strength to the soil due to the suctions that increase contact stresses between the particles. As the ground saturates due to infiltration, the suctions reduce as does the shear resistance in the ground, with the reverse condition emerging as soil saturates and a groundwater table rises. In this case, increasing hydrostatic porewater pressures reduce contact stresses and hence the strength. The relationship between the degree of saturation and the suction becomes a critical means of evaluating the contribution to strength (see Fig. 6).

A safety concept was also set up to make sure that noone was buried during the landslide, since it was predicted that failure would occur within a matter of seconds, and it would not be possible to escape the muddy onslaught. The observational method was used as a decision-making framework depending on the degree of saturation and suction with depth, linked to stability calculations of a predicted failure mechanism (Fig. 6). A traffic light system backed up with appropriate observations, measurements and permitted actions at each level, set up clear command, control and communications between the team members and the local community. A 'red' state meant that the slope could fail at any time and so noone was permitted to pass below the net or within 20 m of the slope.
