PHOTOGRAMMETRIC MONITORING OF AN ARTIFICIALLY GENERATED LAND SLIDE

- **TRAMM (Triggering of Rapid Mass Movements in Steep Terrain)** an inter-disciplinary project conducted in cooperation of
 - Swiss Federal Research Institute WSL,
 - ETH Zurich, and
 - EPF Lausanne.
- **The primary goal:** to improve the **quantification** and **predictability** of hazardous mass movements, such as **landslides**.
- Artificial landslides were generated, and the **mass dynamics were studied numerically**.
- **Two artificial rainfall** events in Ruedlingen (Switzerland), conducted in
 - autumn 2008 and
 - spring 2009 (resulted in mobilising about 130 m³ of debris).
- **Spatial behaviour** of the land slides was monitored using the **photogrammetric technique**.

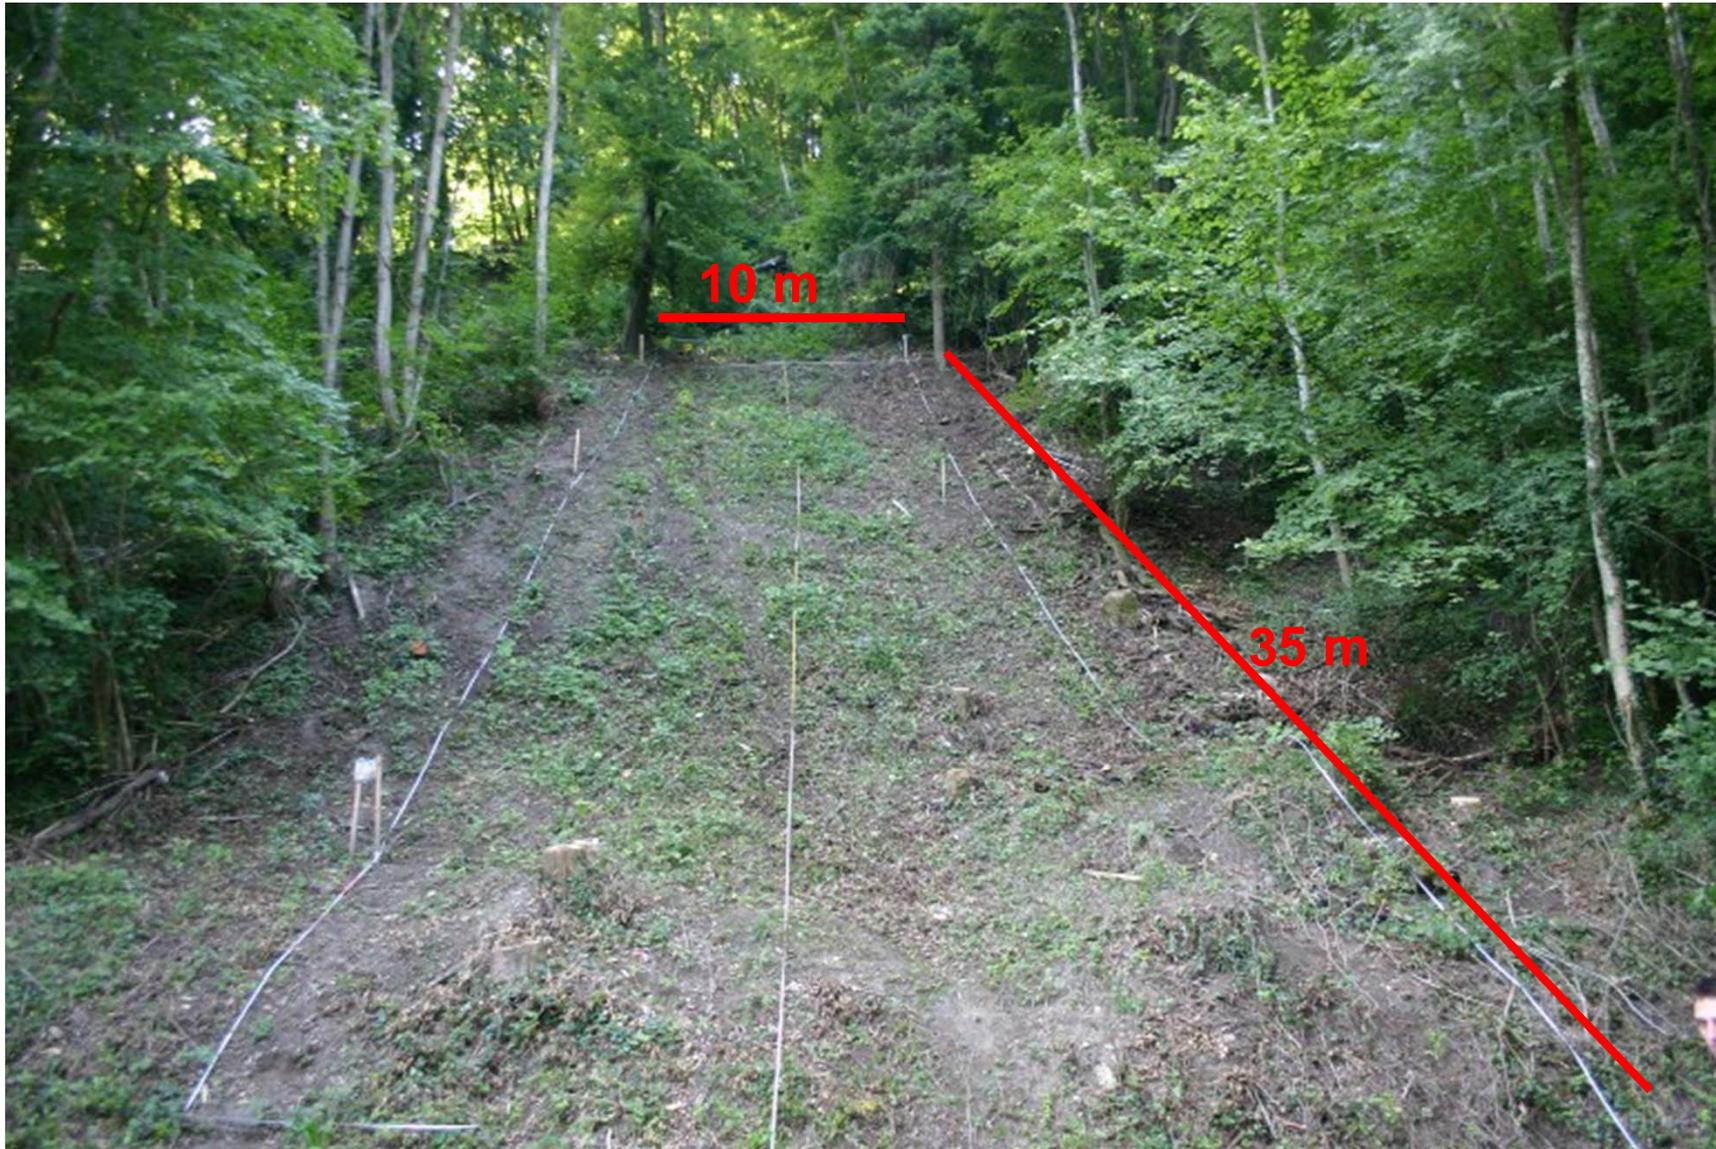
- **Size of the test site:** 10m x 35m.
- **Average slope** 38 degree.

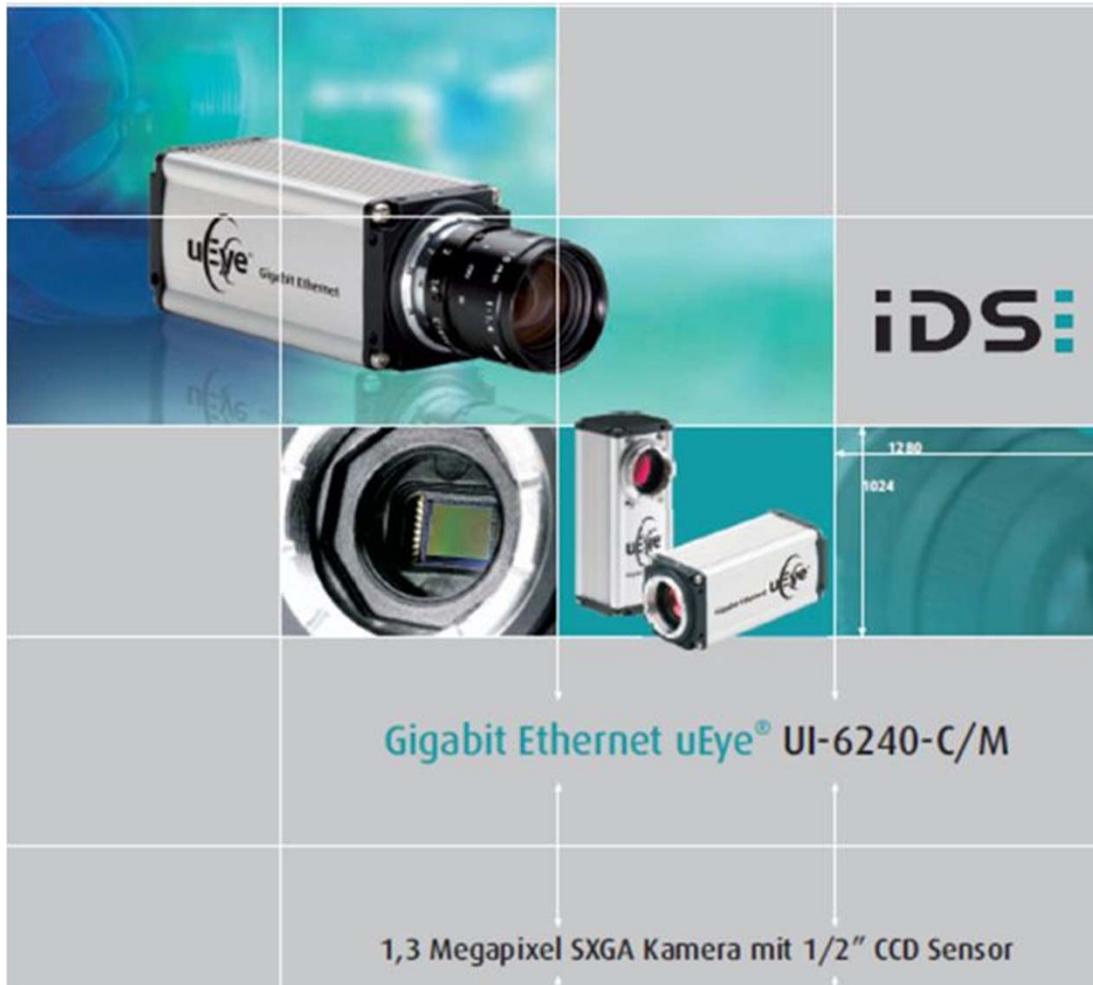
IDS UI-6240 M

- 1280 x 1024 pixel
 - **CCD**, global shutter
 - 14 fps
 - 4.65 micron pixel pitch
 - Gigabit Ethernet
-
- 2 Cams x 8.0mm lens
 - 2 Cams x 12.0mm lens

Based on the network simulations, **hardware** components decided.

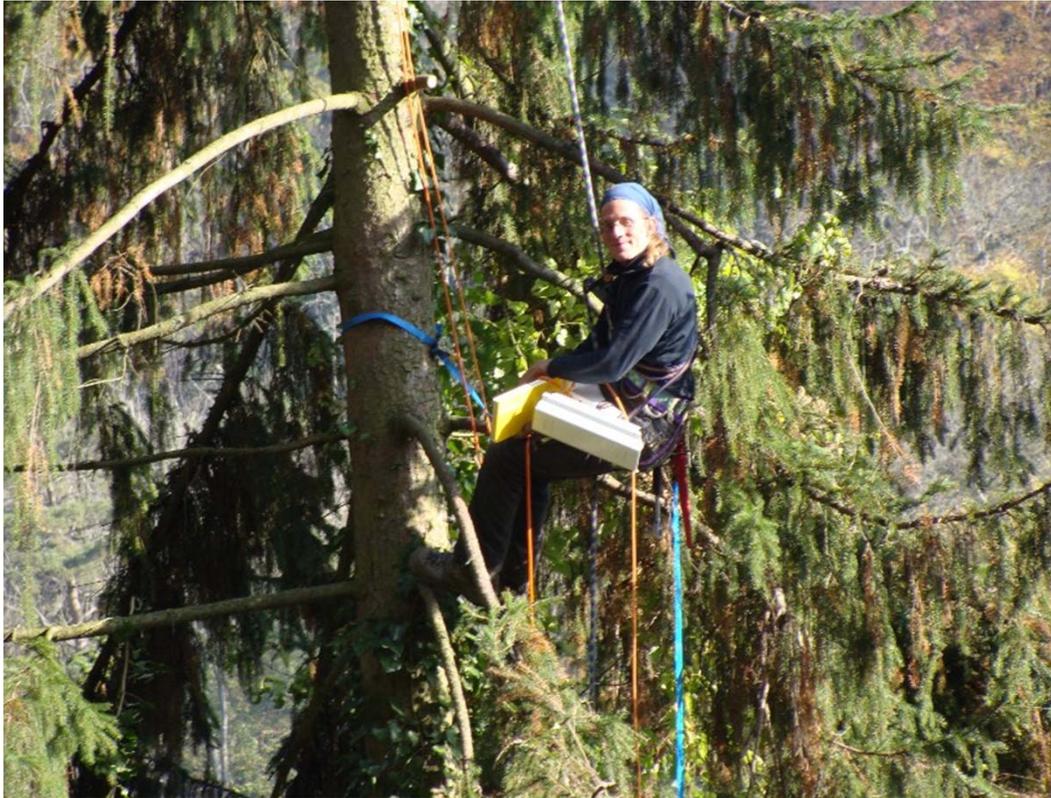
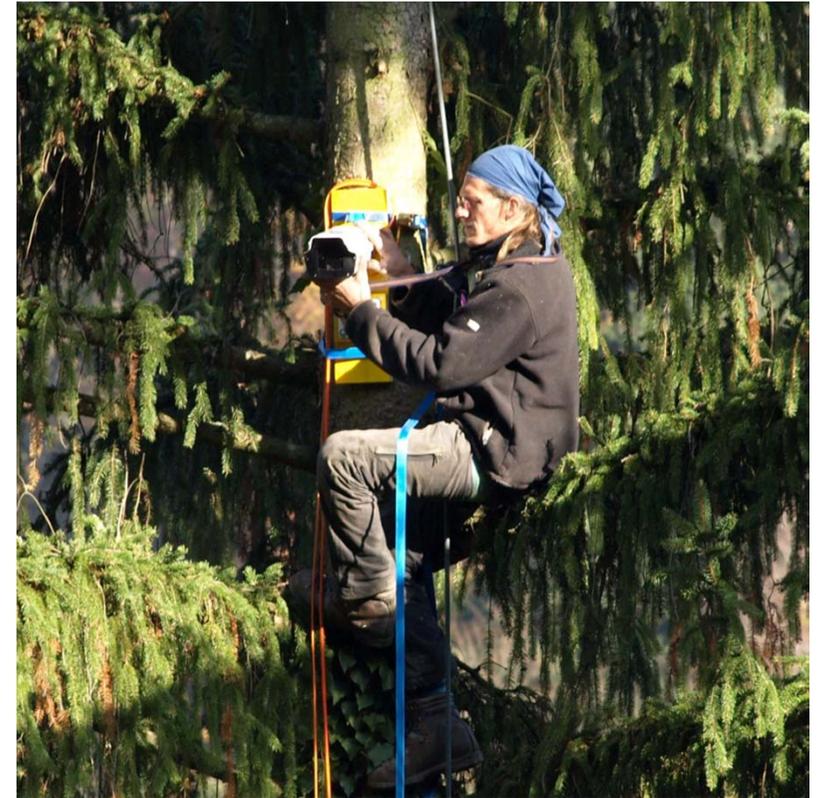
Cameras placed in **housing shields**, which protect them against snow, rain and other environmental effects.

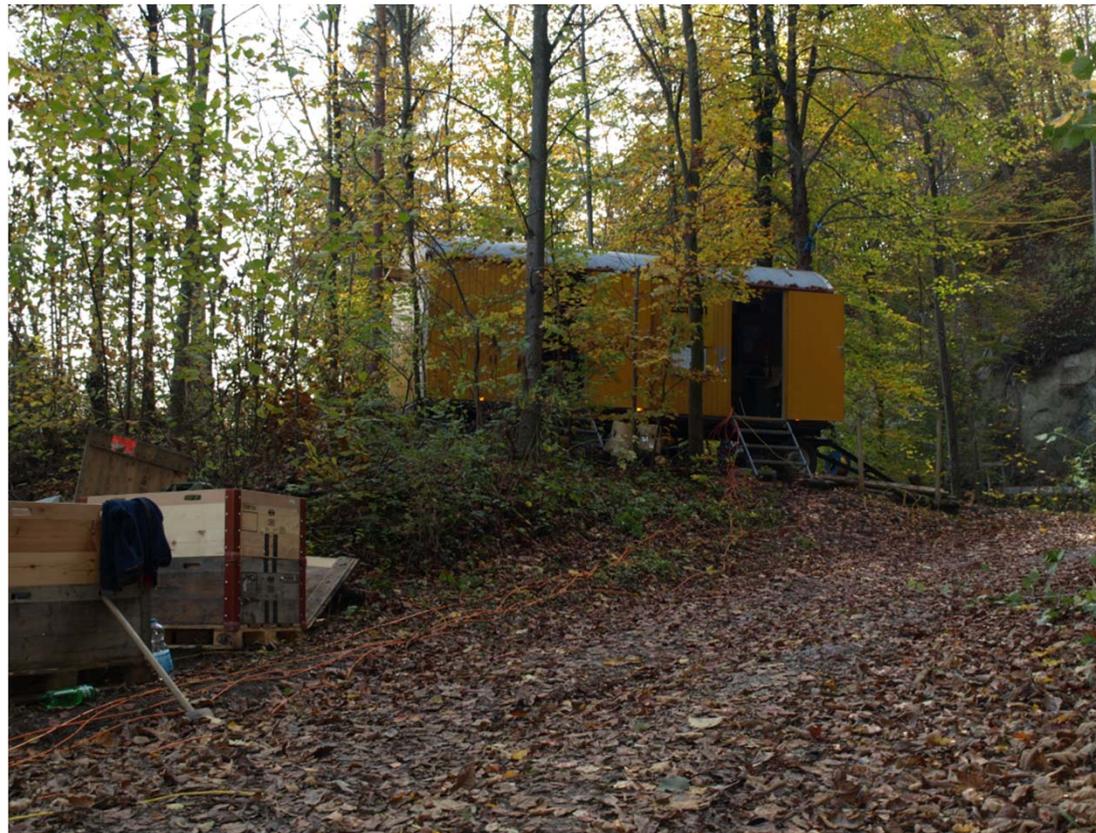
- Cameras connected to a central computer using 100 m **Cat-6** Ethernet cables.
- The control computer was a **Supermicro server**
 - Intel Xeon QuadCore 2.33 GHz CPU,
 - 4 GB DDR2 RAM memory,
 - 16x 250 GB 7200 rpm SATA II harddisks and
 - MS Windows Server 2003 R2 Enterprise OS.
- An Intel Pro/1000 PT Quad Port **NIC** used for the **Ethernet protocol comm.**

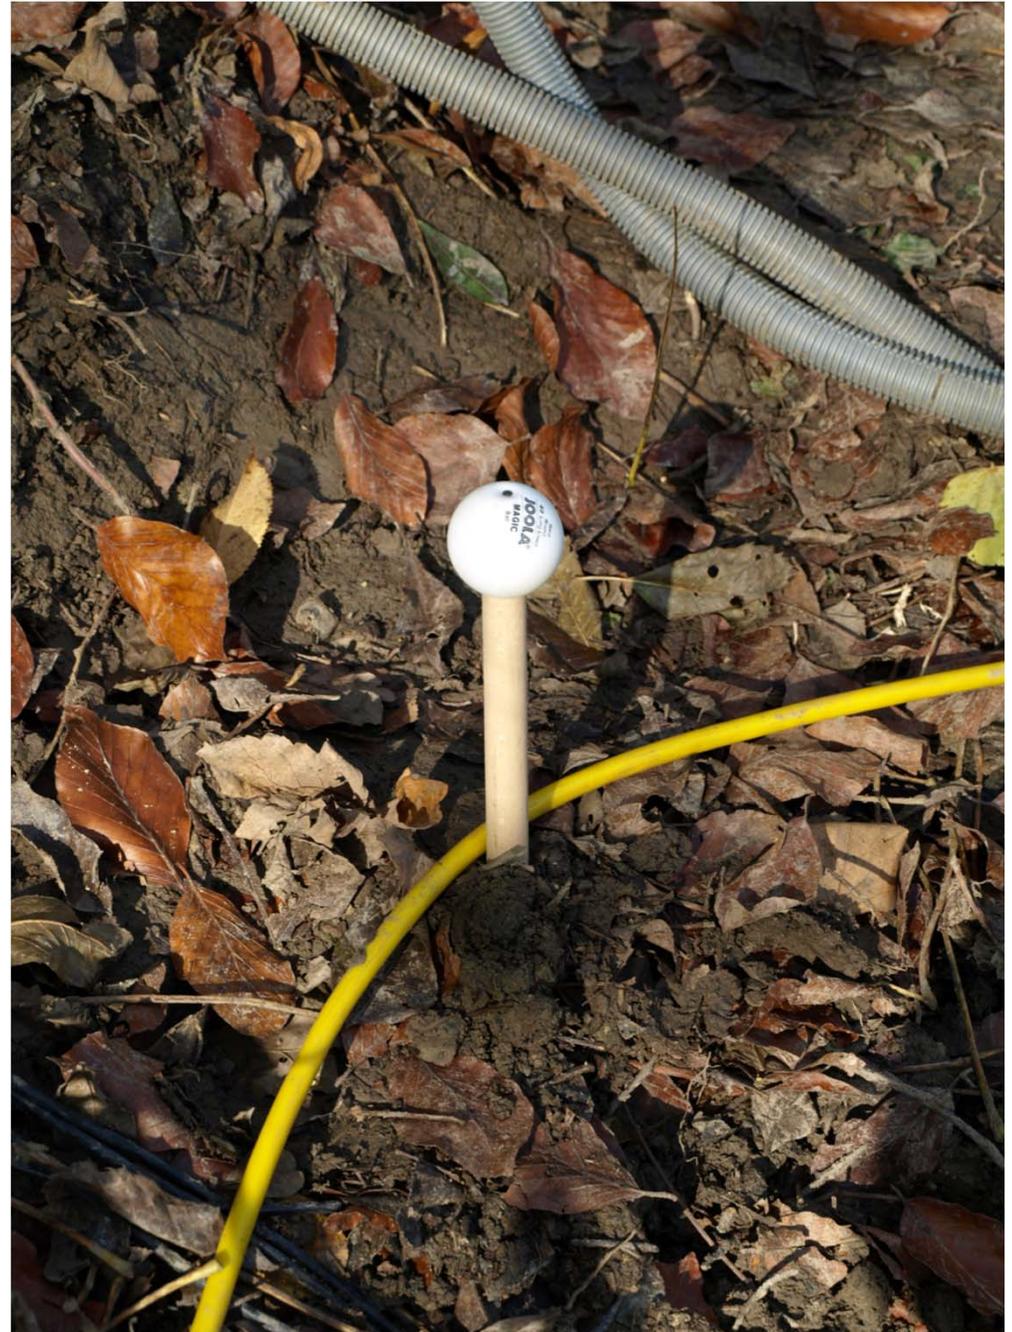
250 white ping-pong balls
(with 40 millimeter diameter)
glued on 20-30 centimeter wooden
sticks.

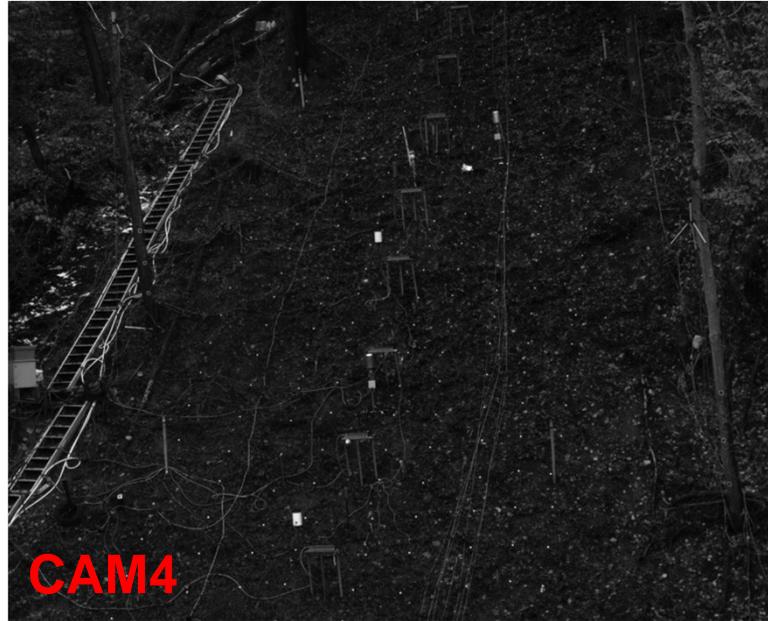
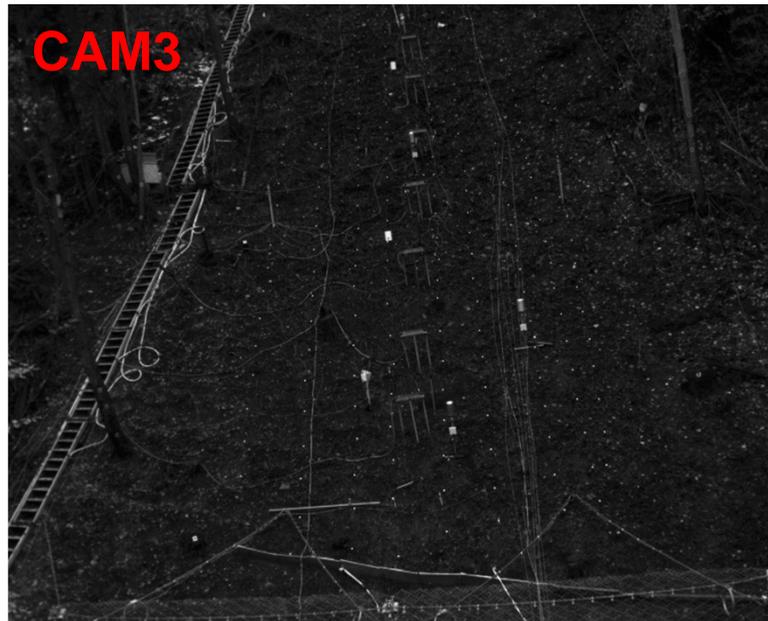
- The **camera calibration** was performed in the field.
- **Ten consecutive image frames** were measured for each of the four cameras.
- The collected image measurements were input to a **self-calibrating bundle block adjustment** procedure.
- Since the camera stations on two tall trees were **not stable platforms** and were moving with the wind, the exterior orientations of the cameras were calculated for each camera/image frame **individually**, by use of the GCPs.

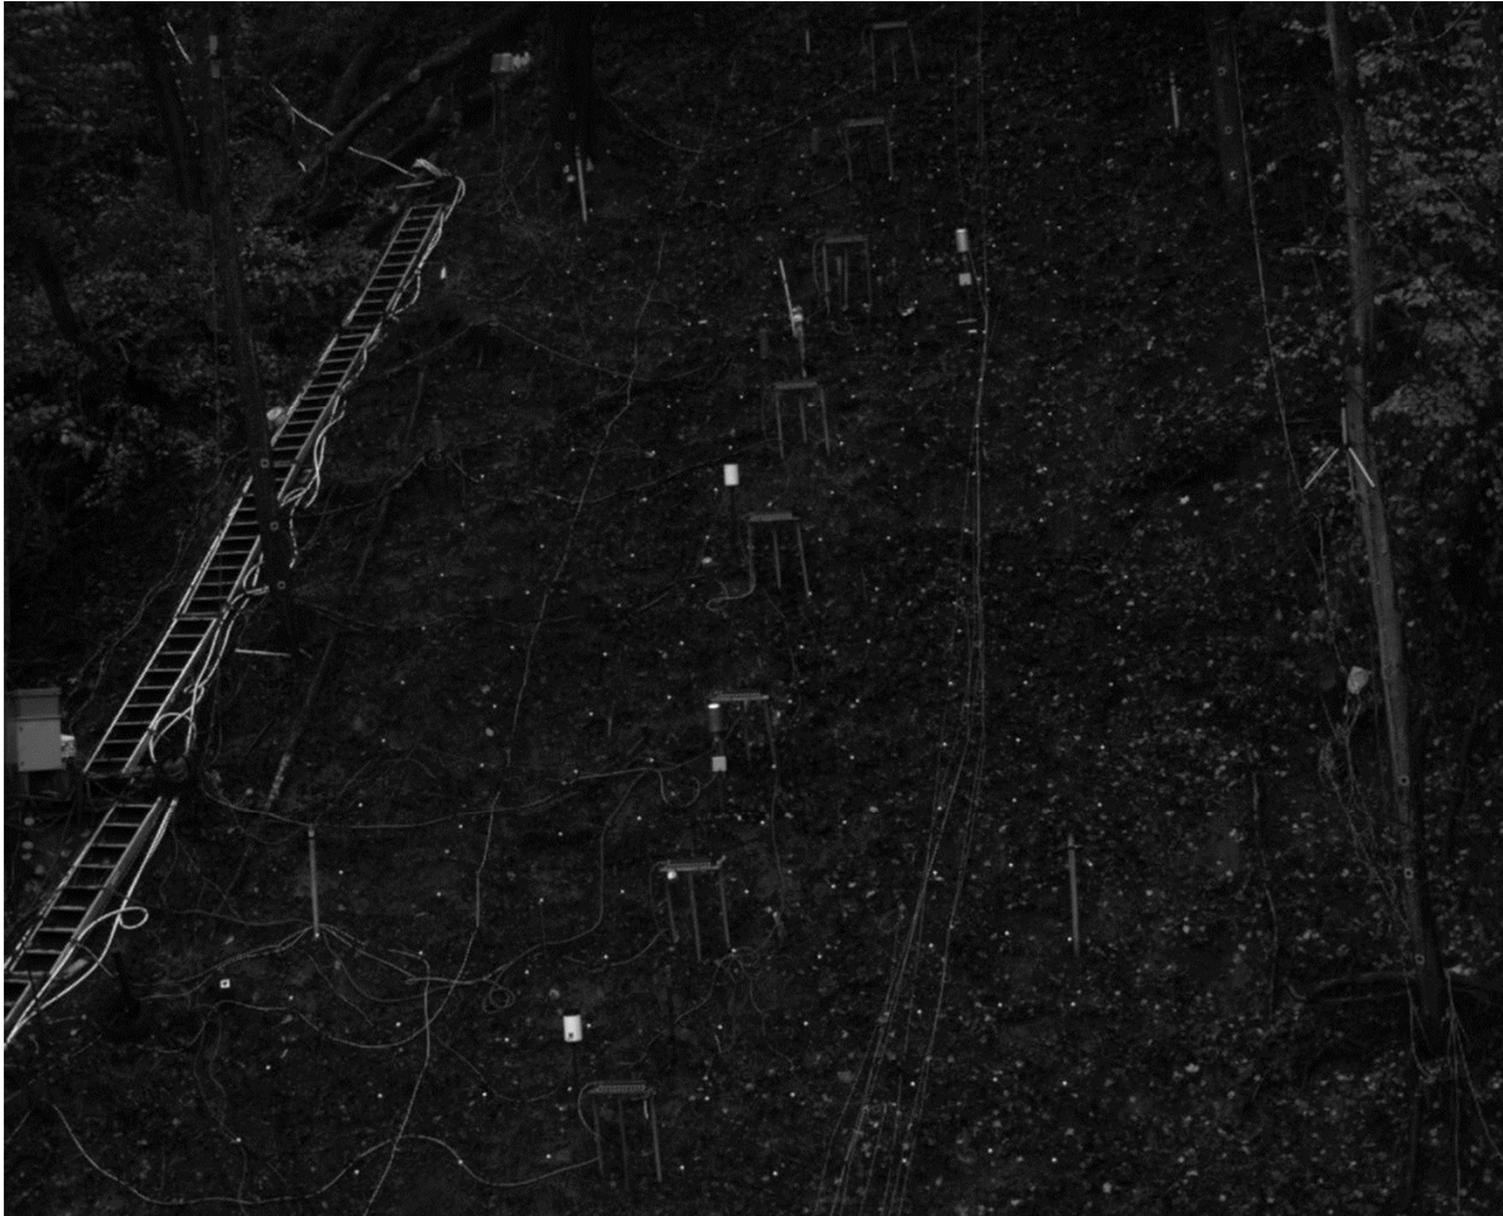
An example of the **CAM4** day time images.

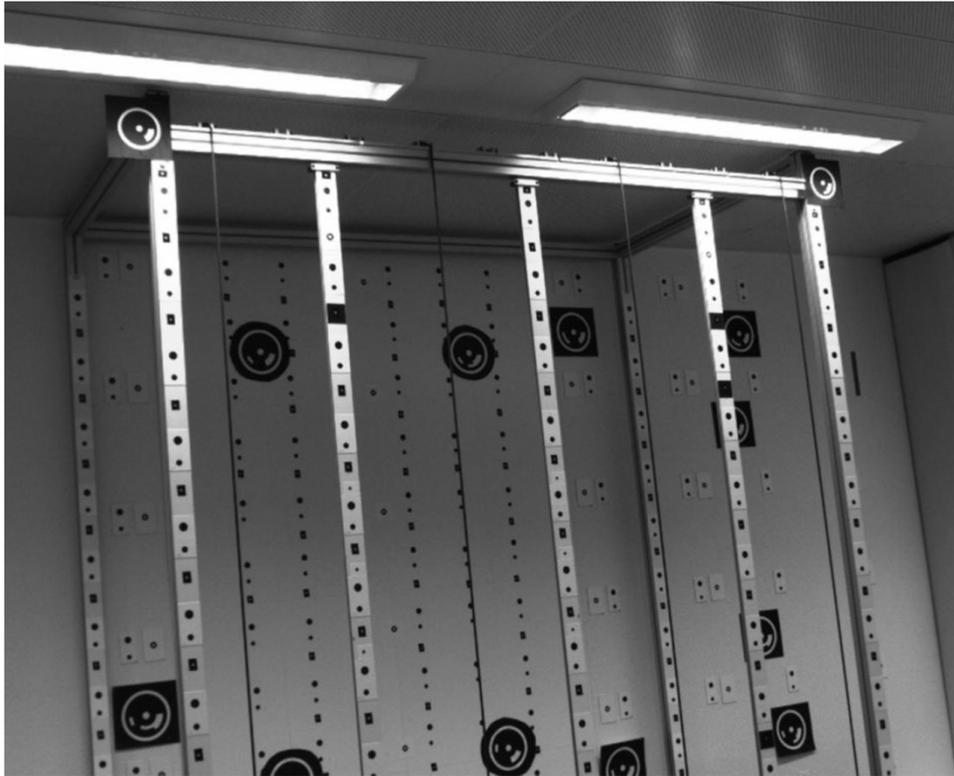
Laboratory Camera Calibration

- In-door testfield
- Self calibrating bundle adjustment
- Point measurement with LS image matching

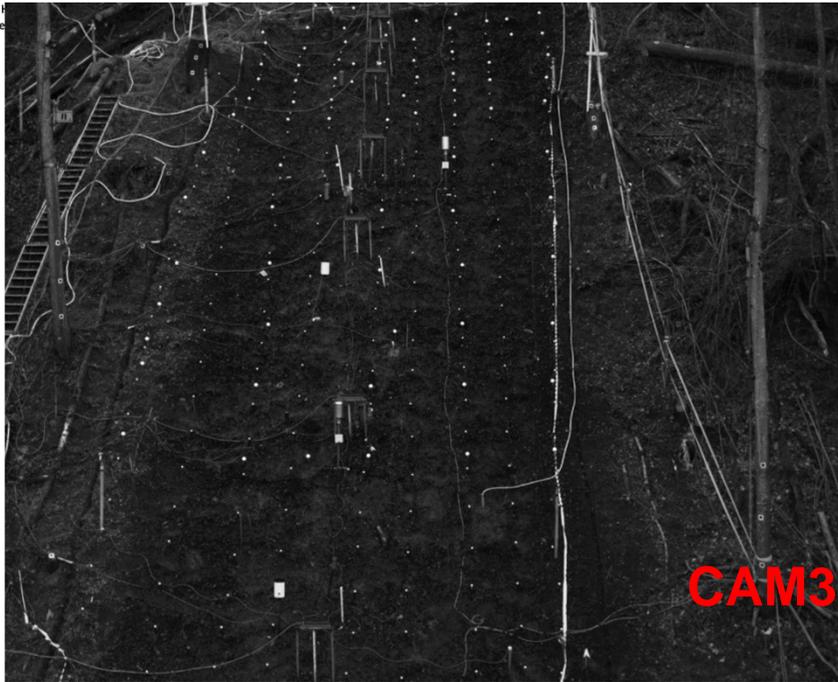
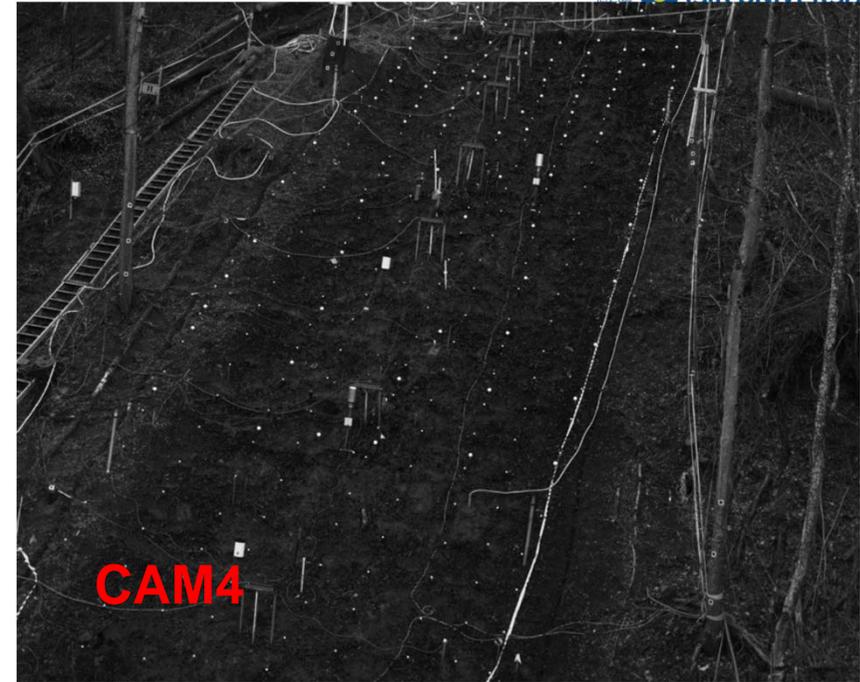
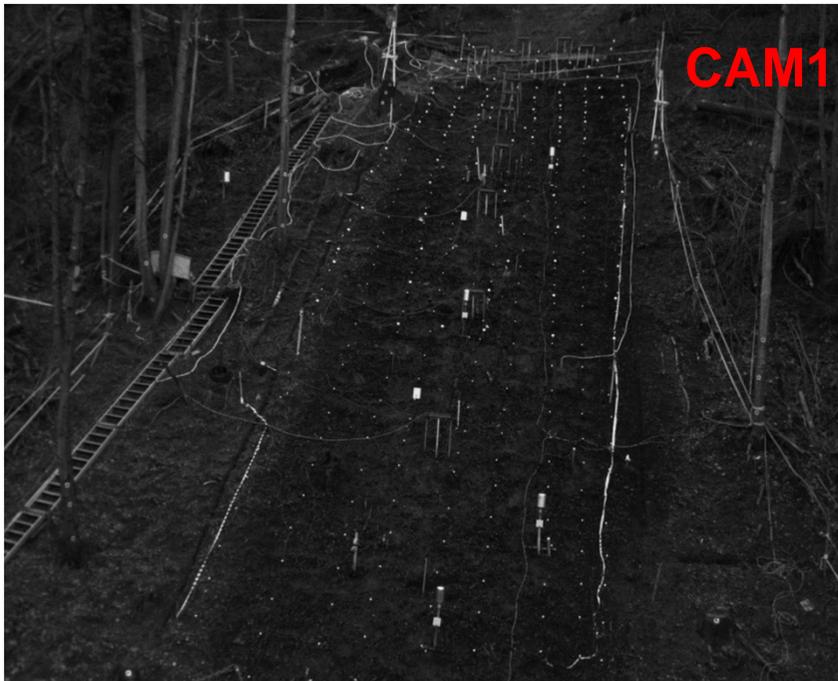
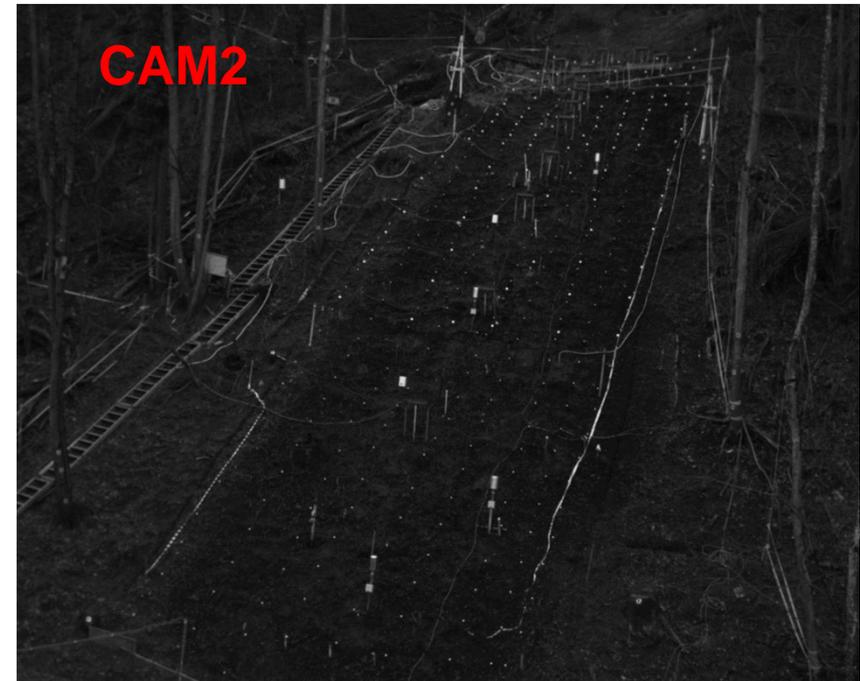
<u>So</u>	<u>Average StdDev X-Y-Z at CHK+TIE points</u>		
CAM1	0.34 micron	0.221	0.477	0.151 mm.
CAM2	0.34	0.187	0.330	0.129
CAM3	0.40	0.141	0.331	0.114
CAM4	0.35	0.134	0.365	0.120

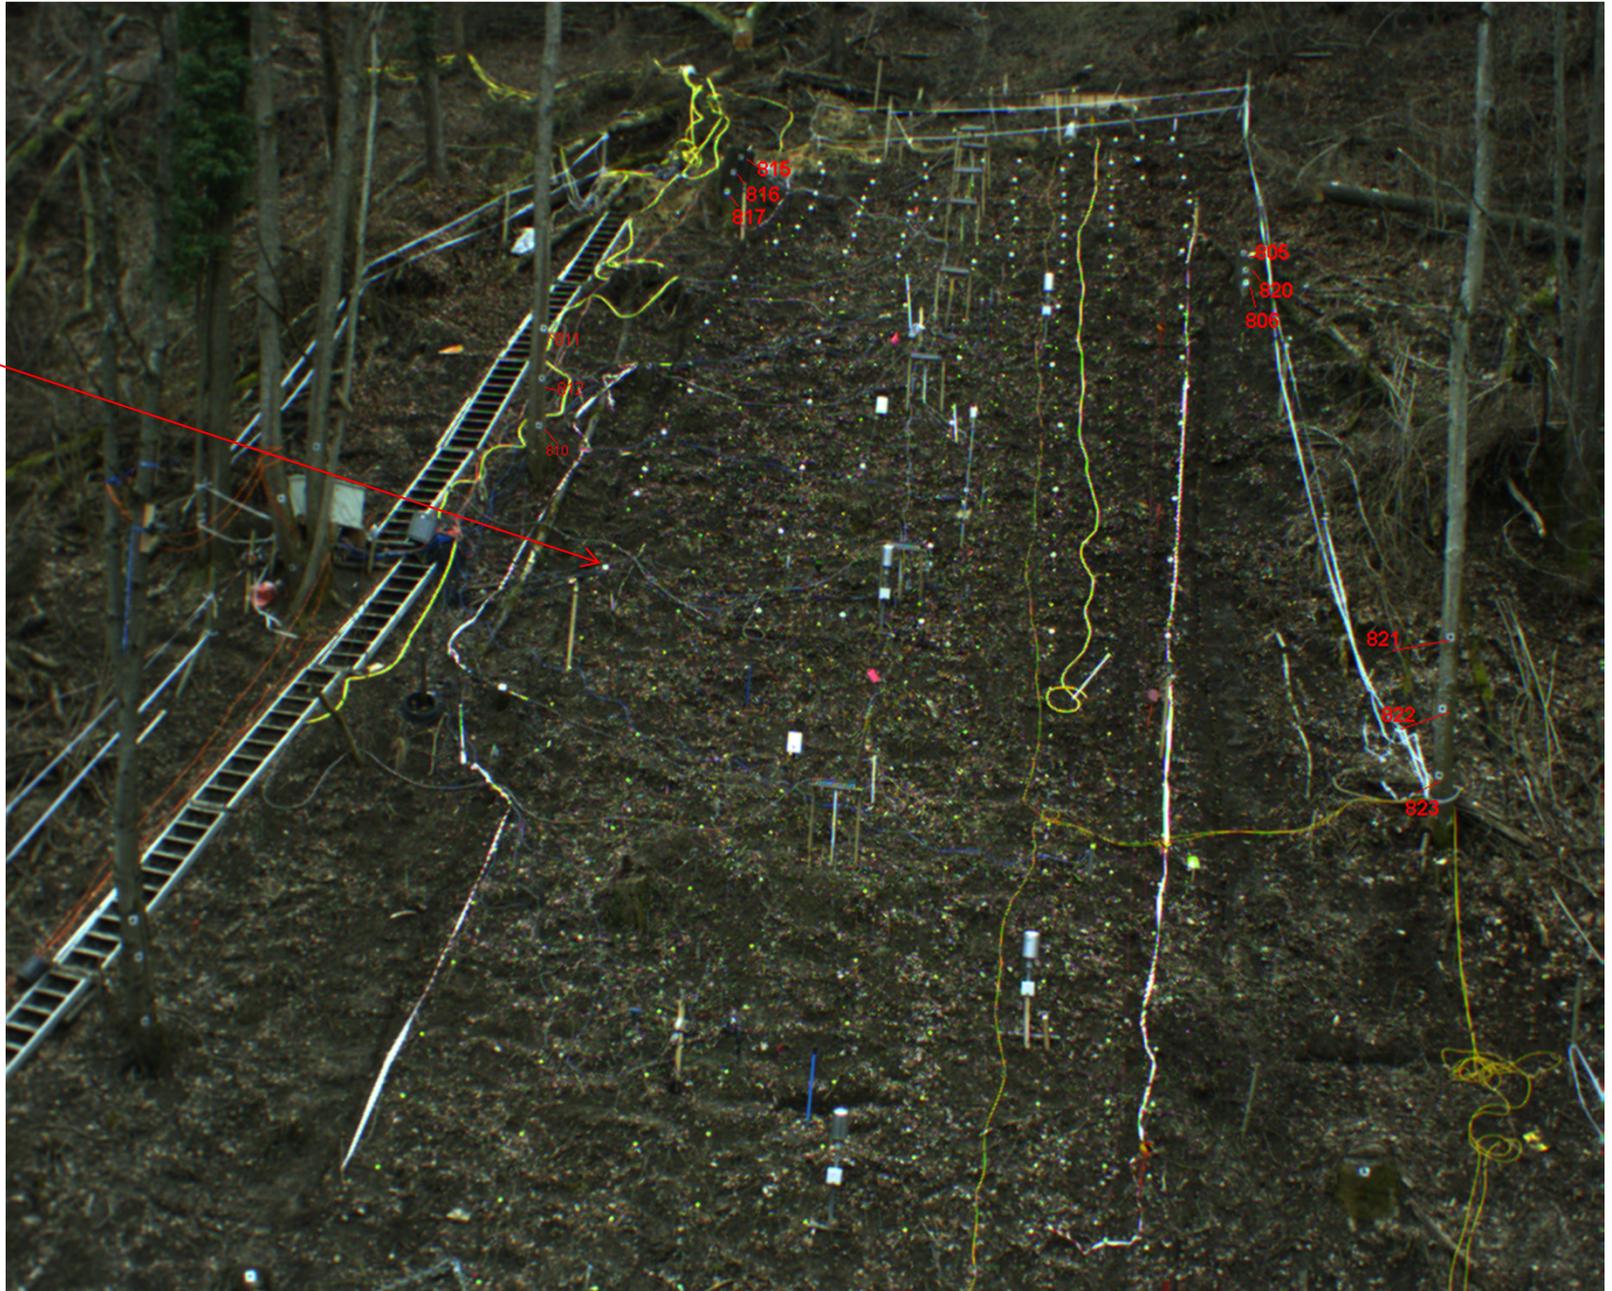
12 GCPs

Tennis balls as targets

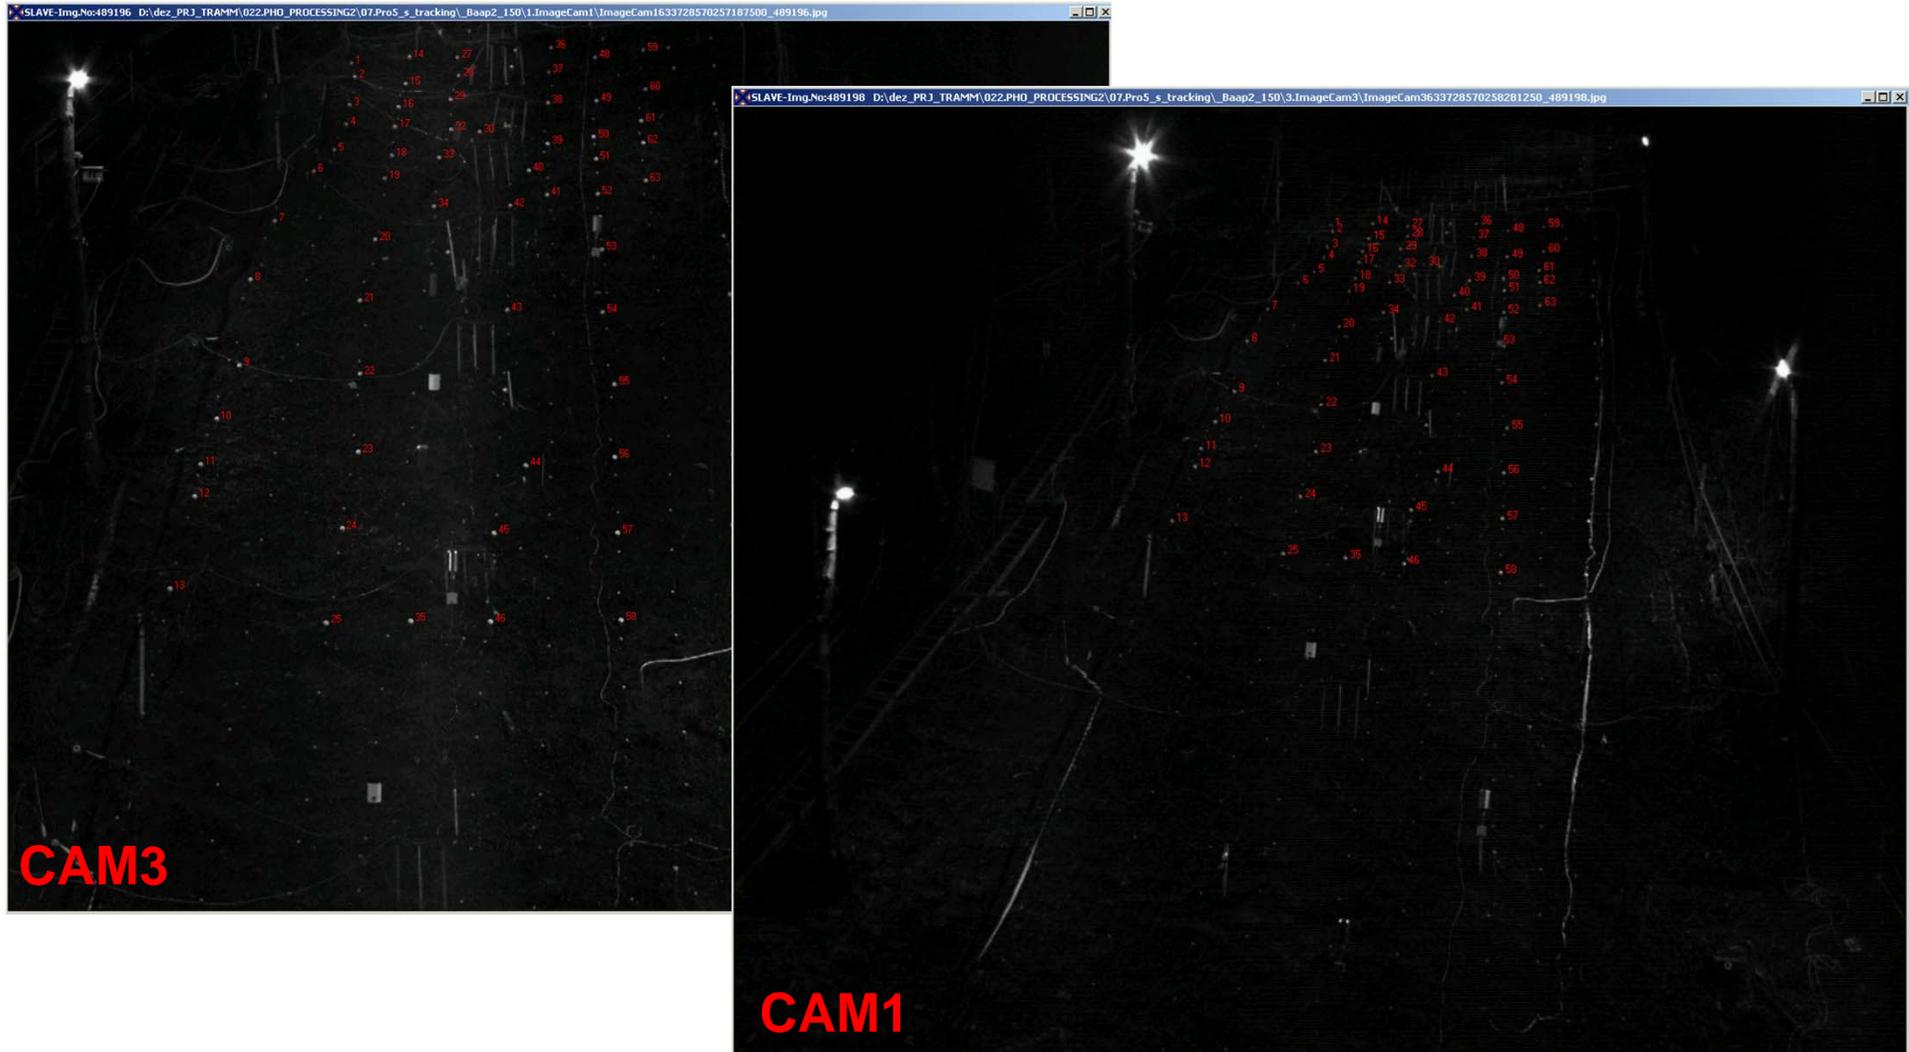
Automatic Image Tracking & Measurement

Automatic image measurement with image tracking + cross-correlation
